CHAPTER 131

Study on Access Roads in Select Locations in Western Pune City

ABSTRACT

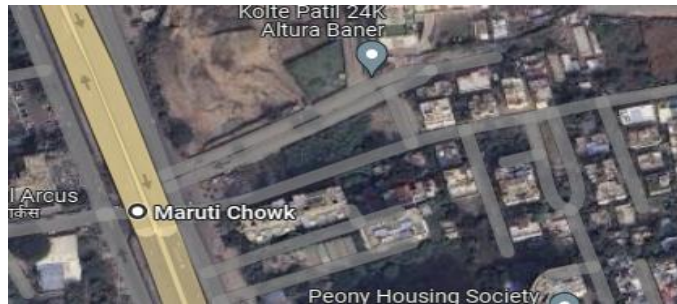
Figure 1: Satellite View of Maruti Chowk to Pan Card Club

The two lane access road had a carriageway width of 6.1m on both sides with a median 1m separating them. The access road was connecting a four lane main road. The shoulder on one side of the road was in poor condition with lot of vegetation growth and the shoulder on the other side was acquired by the private properties. Illegal vehicle parking causing narrowing of carriage way width. Width of the road was not uniform throughout the stretch. The road stretch

had a rigid pavement. The road stretch had a low traffic density. Illegal accommodation by the slum dwellers was observed. Because of this there was a discontinuity in the road stretch and the poor road condition. The length of the access road was approximately 250 meters in which approximately 30 – 40 m was encroached by the slum.
