Failure Analysis of First Stage Gas Turbine Blade

ABSTRACT

Keywords: Gas Turbine Blade; Creep; Corrosion; Fatigue.

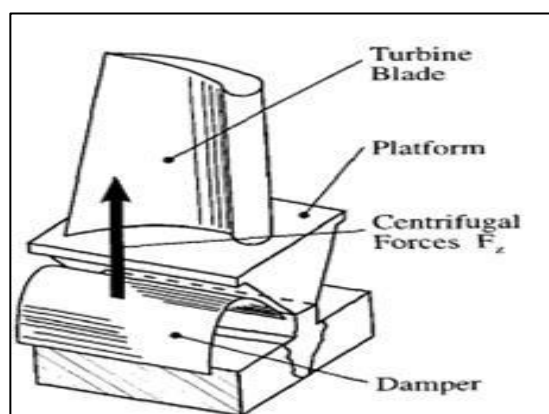
Fig 1: Gas Turbine Blade

computations. The aerodynamic damping is greatly affected by the aspects of the blade section. This damping may be negative, i.e., adding energy to the motion of vibration, and causing flutter of the blade. The third mechanism of damping is friction damping. Friction damper uses dry friction to dissipate energy and thus reduces the stresses. Friction damping takes place whenever two contact surfaces experience relative motion. The centrifugal force arising from the rotation of disc forces the damper against the platform and energy is dissipated, when there is slip motion at contact surfaces.

The blade attachment at the fir-tree joint in gas turbine engines is subjected to high cycle fatigue condition that involves high frequencies and vibration type loads, hence failed due to fretting fatigue. During fretting fatigue process, crack will nucleate and propagate according to severe stress

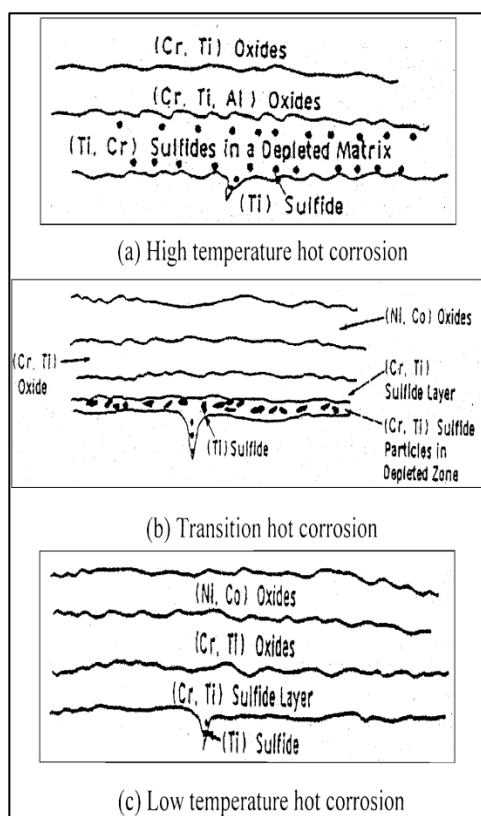
Fig 2: Types of Hot Corrosion

By using an electron beam analyzer, it is found that sulphide particles of chromium and titanium are present in a region below the surface scale which consists of chromium oxide Fig 2(a).

By using an electron beam analyzer, it is found that sulfide particles of chromium and titanium form a continuous layer and the surface scale contains un-protective oxides of Nickel and Cobalt Figure 2(c).

During services, there are corrosion found which has features of both HTHC and LTHC. Hence the name given to this type of corrosion is Transition Hot Corrosion. By using an electron beam analyzer, It is found that the sulfides of chromium and titanium are increasingly agglomerated into large interconnecting sulfide networks and surface scales contains the oxide of Nickel and Cobalt Fig 2(b).

The temperature at the platform region is lower as compare to the airfoil and hence these regions could be prone to type II hot corrosion attack. It is mainly confined to trailing and leading edge regions.

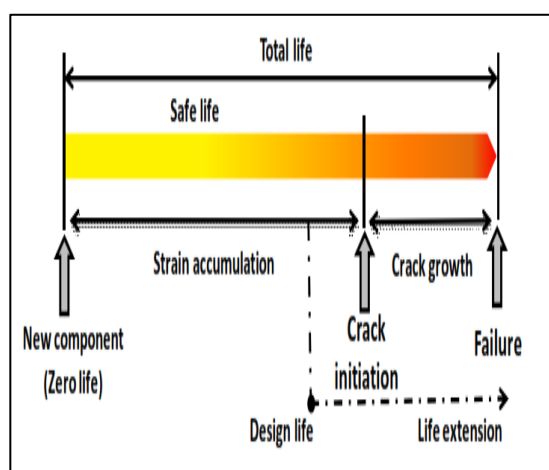
Fig 3: Creep Due to Life Span of Hot Section Components Deformation

can slowly and continuously deform under constant stress over a period of time. The temperature and time dependence of creep deformation indicates that it is thermally activated process. This deformation is the result of Dislocation climb, Vacancy Diffusion, and Grain Boundary sliding. Creep leads to a fracture in components at static stress. Creep is the largest potential problem in applications involving high temperatures and high stress. Betten have described how micro-cracks begin on the surface and propagate until they link into macro-cracks and become visible at the tertiary stage of creep as shown in Fig.[3].

The turbine blades made by nickel base super alloy. The Ni-base super alloy has high creep resistance due to precipitation hardening. The micro-structural changes occur due to blade operation at high temperature include irregular growing of γ' particles (rafting) and formation of carbides in grain boundaries and matrix. This leads to alloy creep properties reduction.
