Porcelain versus Polymer Insulator- A Changing Era in Transmission Lines

K. R. Suri*, A. Gupta**, Y. Anand** and S. Anand**

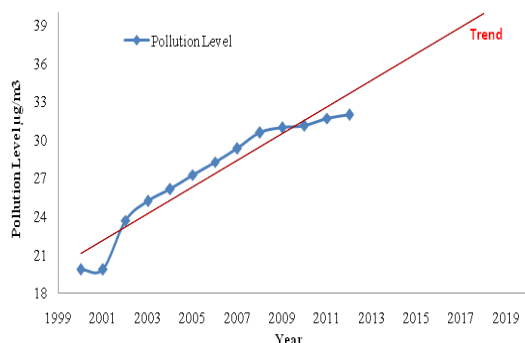
Fig 1: Trend of pollution level in India [1]

The graphical representation of the pollution level in India is given below in Fig.1 [1].

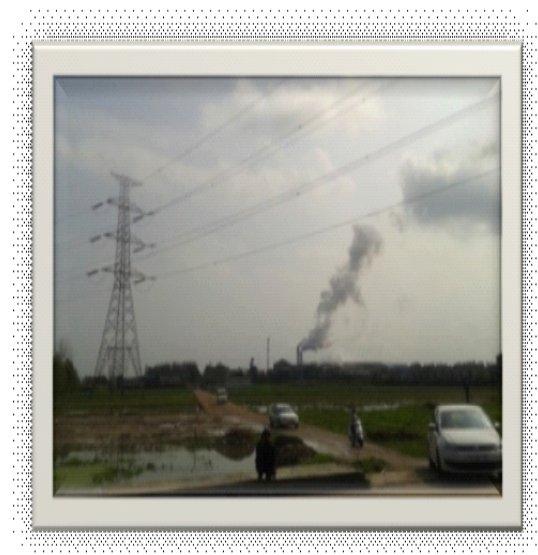
Fig 2(a) : Source of Pollution on Insulators from Power Plants

The pictorial representation of the pollution deposit can be seen in Fig.2 (a) & (b) as given under-

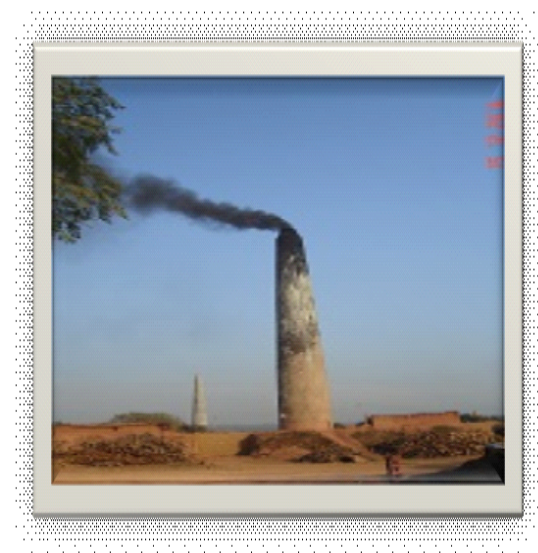
**Fig 2(b) : Source of Pollution on Insulators from brick kilns**

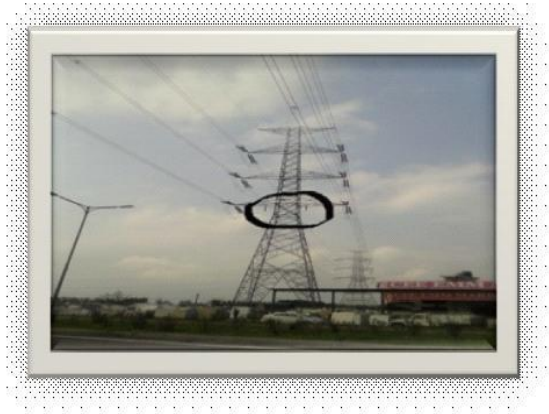
The deposits on insulators are measured in a technical terms called as ESDD (equivalent salt deposit density) and can be seen in Fig.3.

Fig 3: Deposition of Pollution on Insulators

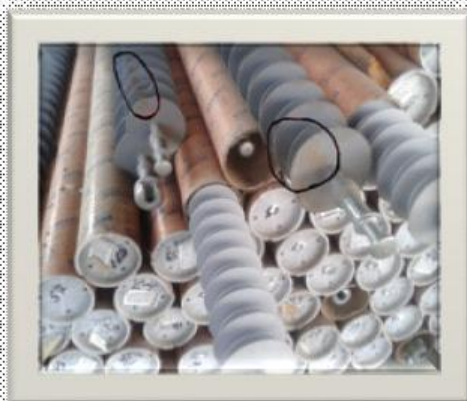
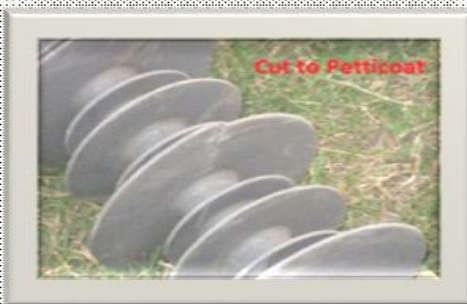
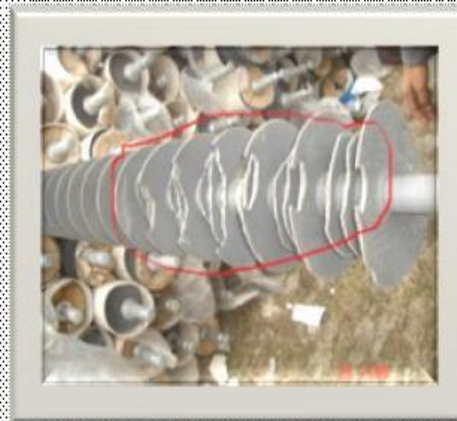
- I Eating by rats etc during storage
- ii Notching by birds
7. iii. In the event of damage, whole string requires replacement. Whereas in porcelain replacement of damaged /broken insulators is possible.
- iii Bad storage- Due to bad storage petticoat has a tendency to shear. Polymers have also tendency to develop algae, fungus and lichens. This is bluish-green and yellowish type deposit on petticoats. This reduces ph value, lowers hydrophobicity and decolourisation, finally drying the bands leading to breakage of the insulators.

The pictures of different limitations of the polymer based insulators are presented below in figures 5(a)-(d)
